# **ENGINEERING INVESTIGATIONS AT INACTIVE HAZARDOUS WASTE SITES**

**PHASE 1 INVESTIGATION  
Amenia - Route 22 South  
Site No. 314006  
Town of Amenia, Dutchess County  
Final - August 1986**

AMENIA - ROUTE 22, SOUTH SITE  
TOWN OF AMENIA, DUTCHESS COUNTY  
NEW YORK ID NO. 314006

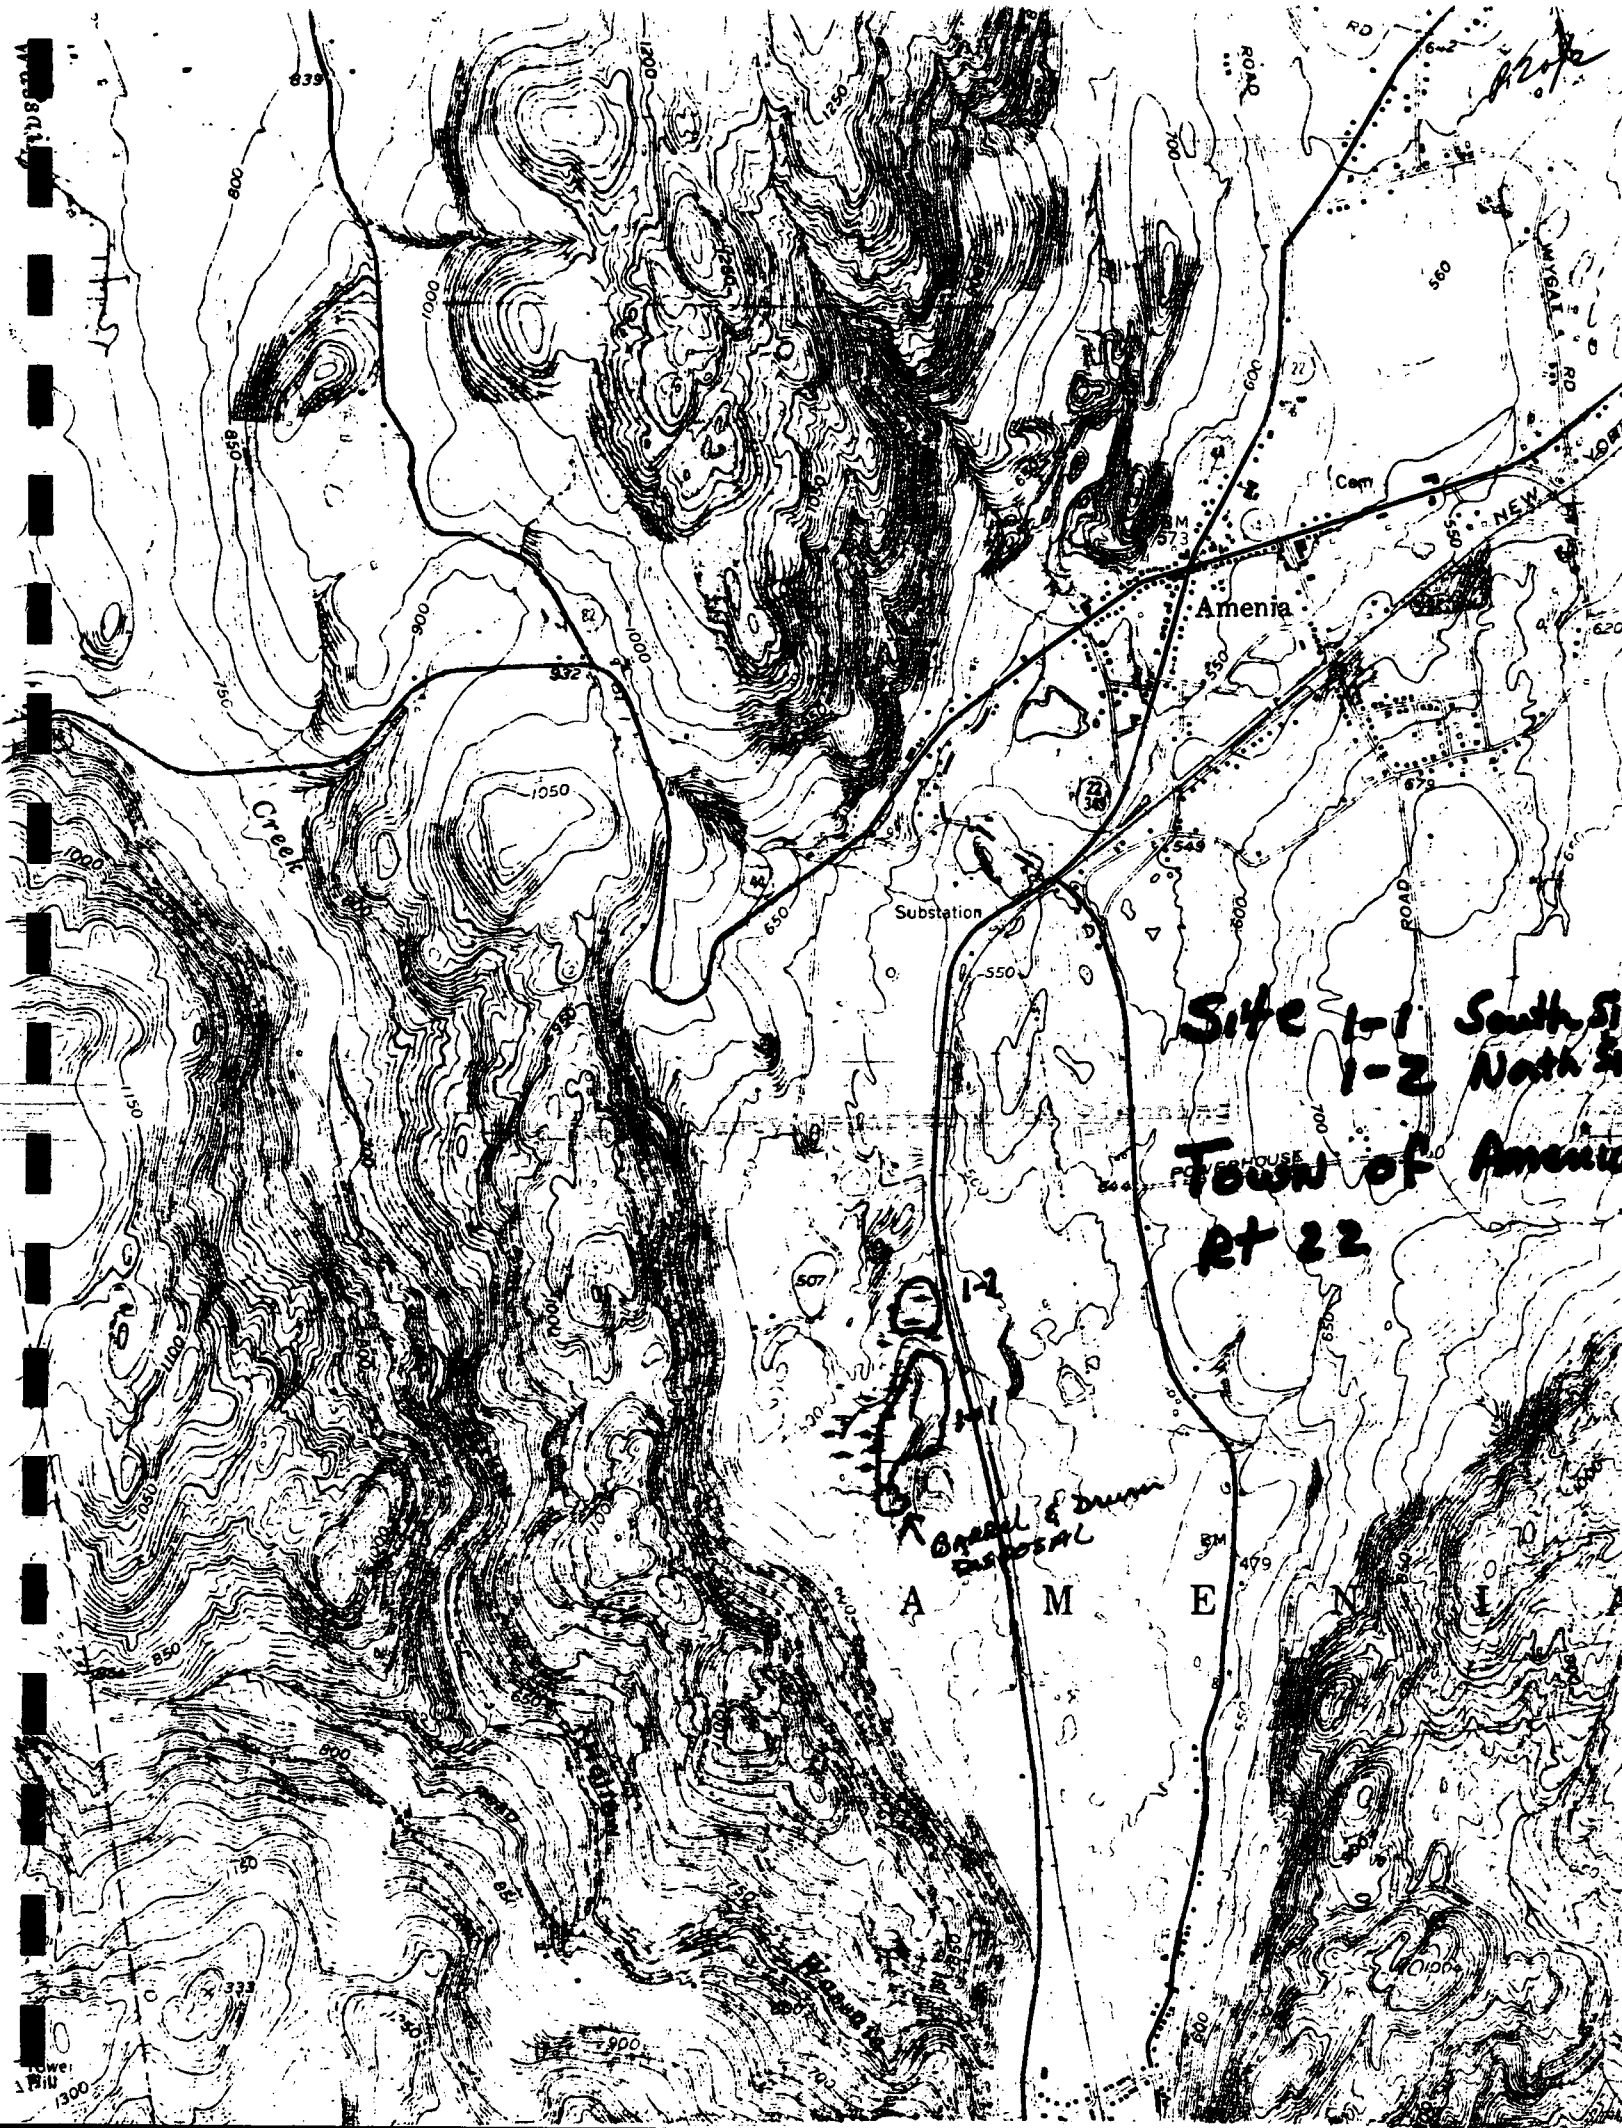
Source: Gerber 1982

till covered mountains as shown on Appendix Al.3-1 (Gerber 1982). Based upon the available literature, hydraulic connection between these two general aquifers cannot be confirmed. However, because bedrock is reportedly within 3 ft of ground surface in the immediate vicinity of the site, the bedrock aquifer, as well as the glacial sediment aquifer, may be affected by conditions at the site.

WATER RESOURCES STUDY FOR DUTCHESS COUNTY
